IMPROVEMENT THE PROCESS OF PAINTING CAR COCKPITS' ELEMENTS

MOLEND A Michal

Silesian University of Technology, Akademicka 2A, 44-100 Gliwice, PL
The Institute of Production Engineering
E-mail: michal.molenda@polsl.pl

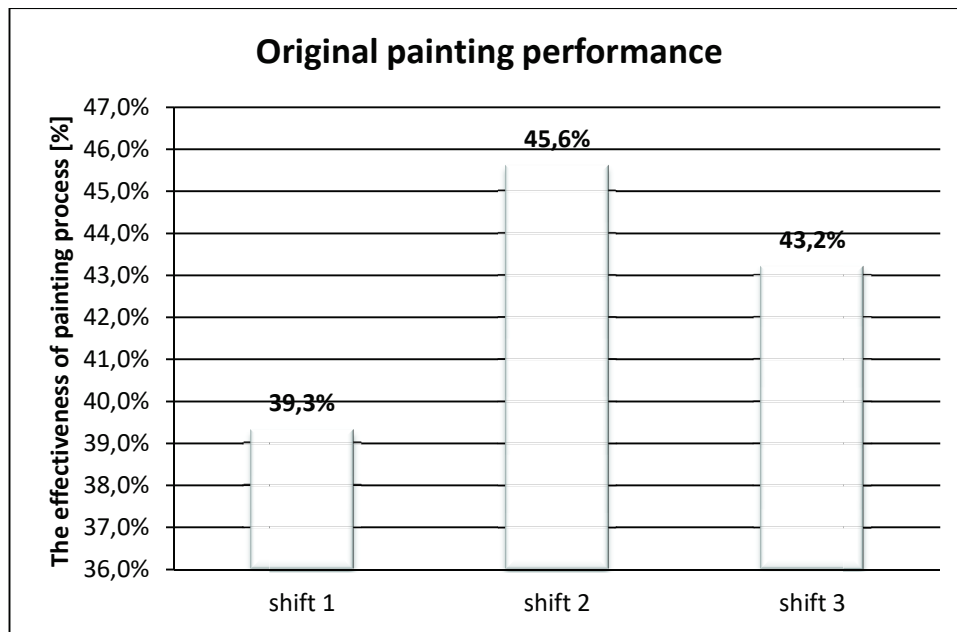
Fig. 2. Original painting performance

The team analyzed the quality control cards for each shift made in one month. Cards were the primary source of information on the number of incongruent items that required repair or re-paint. Figure 2 shows the effectiveness of lacquering - percentage of congruent elements in one month for each shift.

The graph shows a highly adverse image of the painting process. Effectiveness of process in the range of 39.3% - 45.6% was rated by the management as highly unsatisfactory. The objective of the team in the first stage was to increase the efficiency of the varnishing process on each shift to a level of 60%.

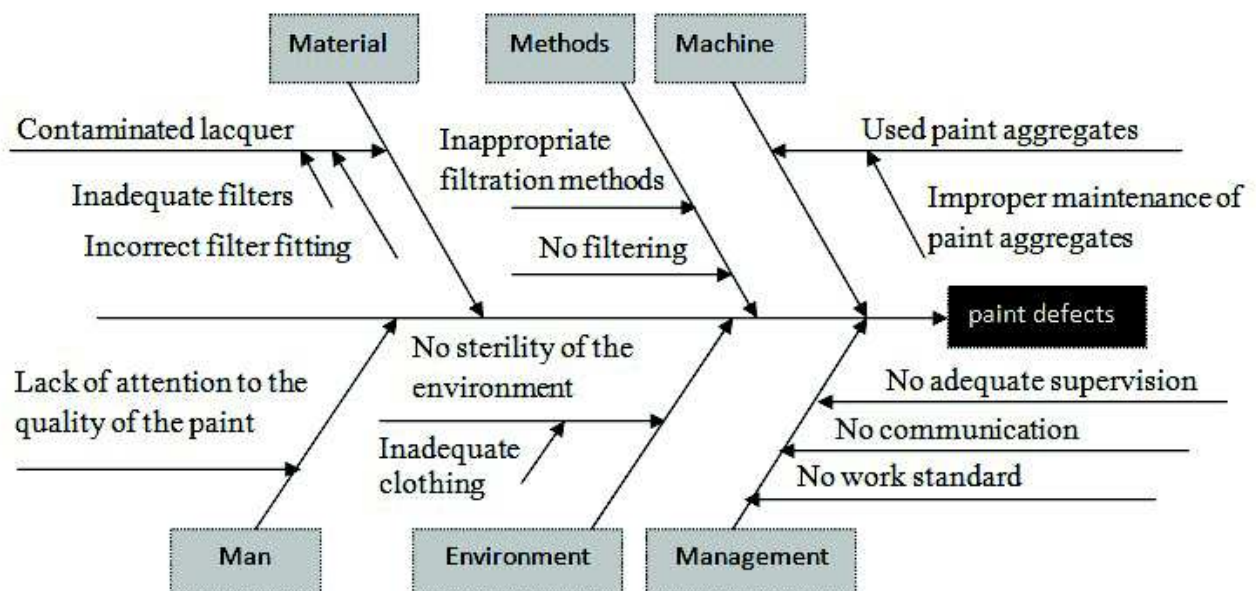
Fig. 3. Ishikawa chart for defect of the lacquering process

A number of main causes and necessary corrective actions have been identified through the use of causal analysis. The causes of the defect of the painting process are shown in the Ishikawa diagram - Fig. 3

The contaminants contained in the lacquer were the main cause of the inclusions. They were due to the improper and poorly installed filter, the material through which the lacquer was poured in the first phase of painting preparation. It was necessary to change the filter. The filter used initially had fibers with a density of 400µm and is currently 100µm. The new filter stops most contaminants. In addition, the filter was loosely mounted on the paint container, which caused the paint to float outside the filter. Thanks to the special stand the filter is stable and easy to clean. Many of the problems stemmed from the fact that rigorous lacquer filtering standards have not been established. The filters were repeatedly used, what is worst, ignoring the direction of pouring. The problem was solved using a new filter design. Currently there is no possibility of confusing the direction of filtration.

Another cause of paint contamination was the lack of standards in the maintenance of equipment - guns (spray guns). It was necessary to replace the spray guns with the introduction of compulsory maintenance. Each cleaning of the equipment is currently listed in a special sheet under which the person responsible for cleaning is signed.

The next identified cause of the inclusions in the paint was the contaminated work clothes of the painters. Before applying corrective measures, 2-piece garments, i.e., trousers and lacquer blouse were used. The improvement in this case is the introduction of a workwear anti-static one-piece suit. As a result, it is no longer a source of contaminants in the form of textile fibers that get directly to the lacquer sprayed or floated in the air, settling on freshly lacquered elements.

On the pump for the paint to the aggregates have also been changed filters with the method of installation. The same density as with the paint filter is 100µm, the filter is double, and the assembly is more professional and durable.

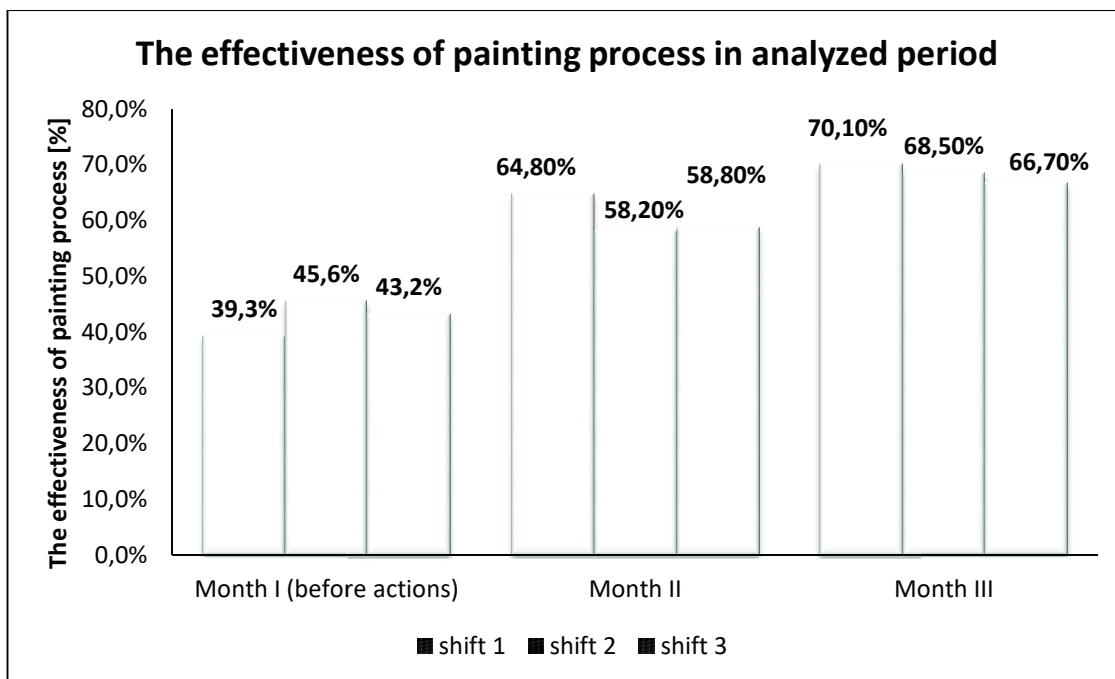
Fig. 4. The effectiveness of painting process in analyzed period

During the next 2 months, the effectiveness of the lacquering process was analyzed. Based on the data collected in the control sheets, the indicators were compared for a total of 3 months. The results are shown in Figure 4.

Thanks to the introduction of a number of activities described in the article, the painting process has been improved. The improvement was noted already in the following month. The effectiveness of the lacquering process has reached the assumed level of 60% in all 3 shifts after 2 months. Not to mention the obvious benefits of less lacquer usage. The benefits of corrective actions are increasing the amount of space available in the product store where incongruent items are stored. Organizational benefits have also been gained, thanks to the mixing of the number of repainting has facilitated the planning of production of other elements.
